Andreas Wagner, CIH, ROH
Golder Associates Inc.
awagner@golder.com
+1 904-305-7830

Assessing and Mitigating *Legionella* in Building Water Systems of Assisted Living Facilities

**January 14-16, 2019
Atlanta Marriott Marquis**

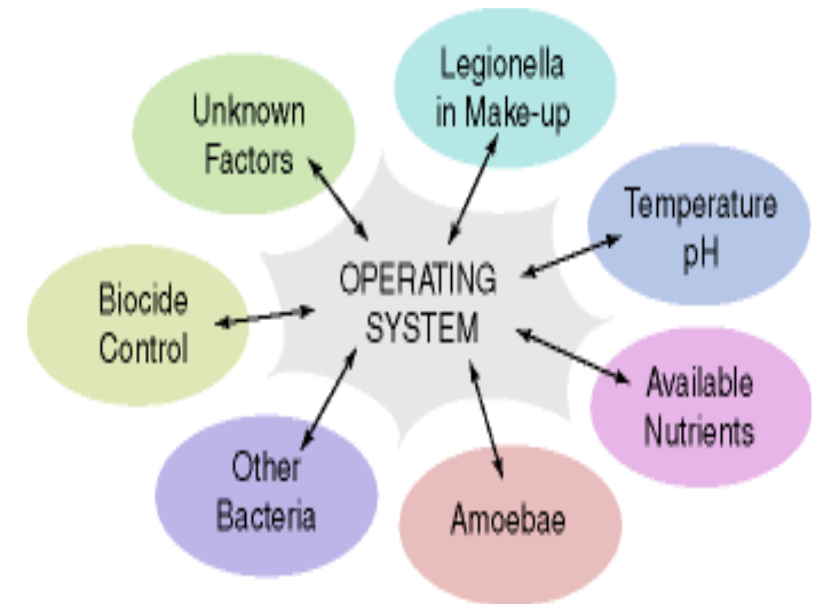
Factors affecting *Legionella* colonization and proliferation

- Water conditions that tend to promote the growth of *Legionella* include:
 - Stagnation
 - Temperature: 68 – 122 °F (20 – 50 °C)
 - pH between 5.0 and 8.5
 - < 0.5 ppm residual Chlorine
 - Sediment / scale / biofilm
 - Other microorganisms such as algae, flavobacteria, and Protozoa which supply essential nutrients and can harbor the organism

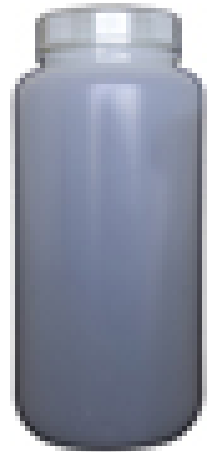
250 mL or 1 L Sterile bottle with Sodium Thiosulfate preservative
